LAKEWOOD BELLHOUSING Alignment Procedure

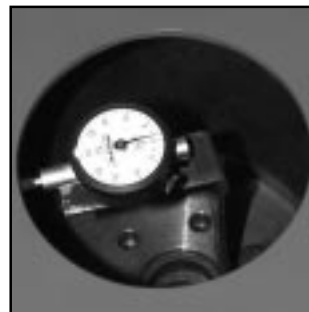
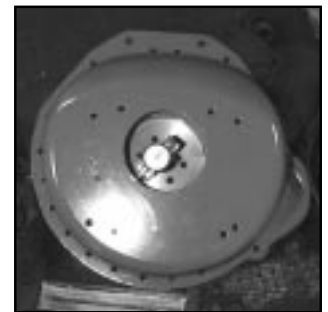
WELD-ON DOWEL LOCATING KIT

Designed for use on race cars that are frequently dis-assembled, this kit eliminates the need to "dial-in" the bellhousing after each removal. For Ford or Mopar vehicles with .500" dowel holes use #15980. For GM vehicles with .622" dowel holes use #15981. Welding is required.
